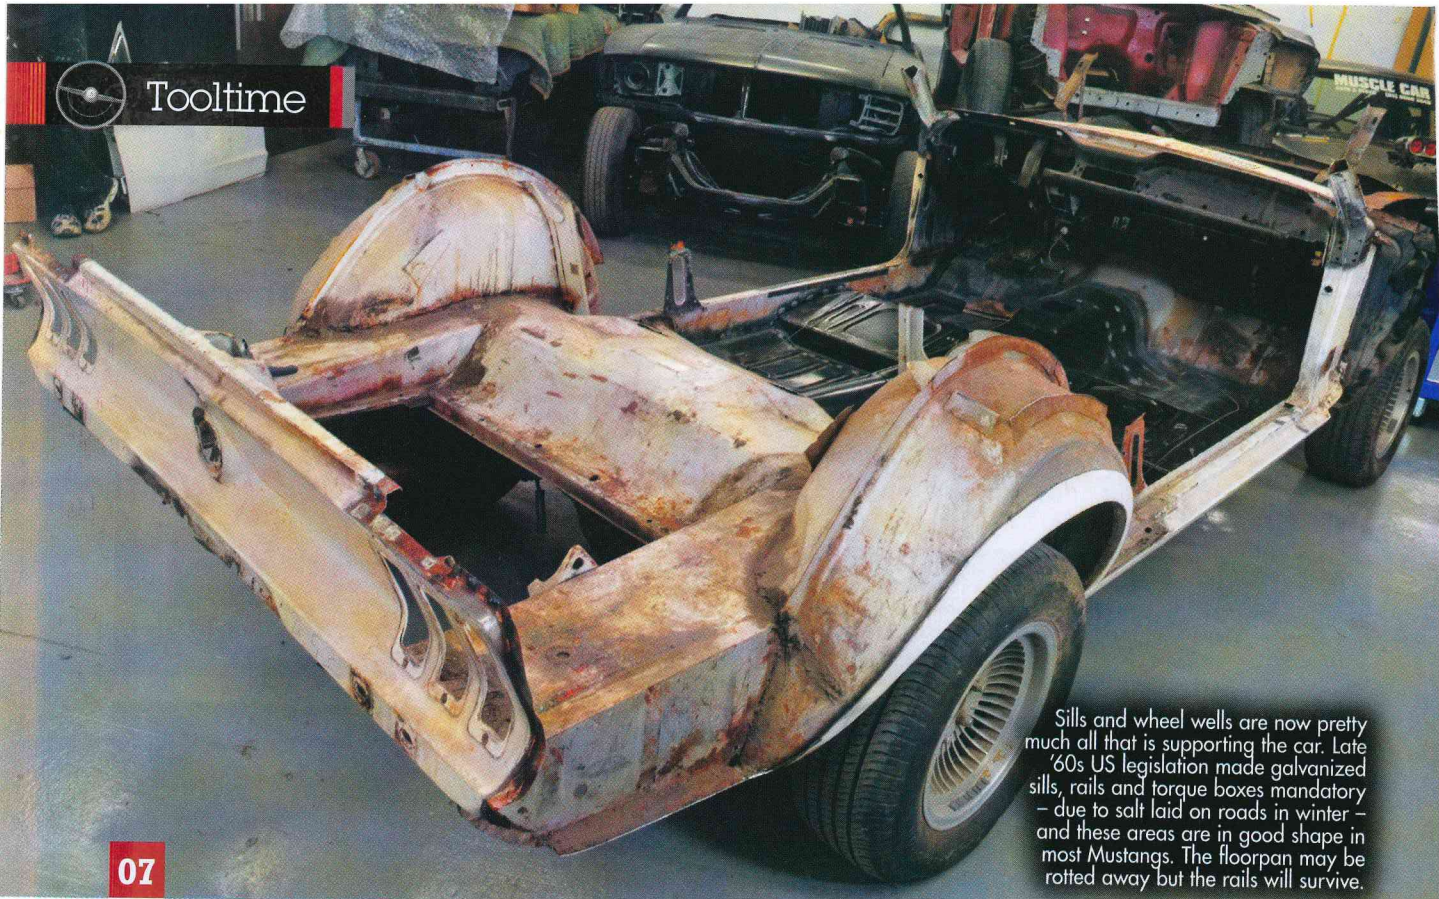
07

Sills and wheel wells are now pretty much all that is supporting the car. Late '60s US legislation made galvanized sills, rails and torque boxes mandatory – due to salt laid on roads in winter – and these areas are in good shape in most Mustangs. The floorpan may be rotted away but the rails will survive.

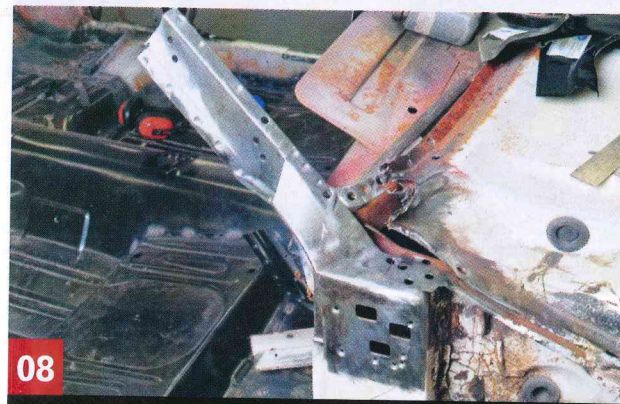
08

George has unpicked and removed the lower outer section of the B-pillar ready to accept the B-pillar section that's part of the Taiwanese replacement panel.

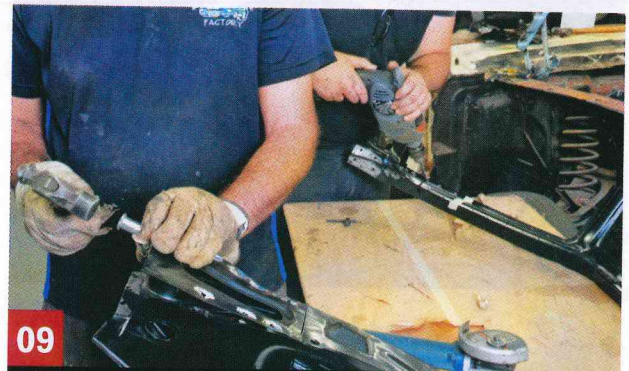
09

The B-pillar on the aftermarket panel assembly extends right to the sill. Because the old B-pillar support was left sandwiched in the body, this bit has to be removed from the aftermarket panel. This is being unpicked to avoid holes in the panel.

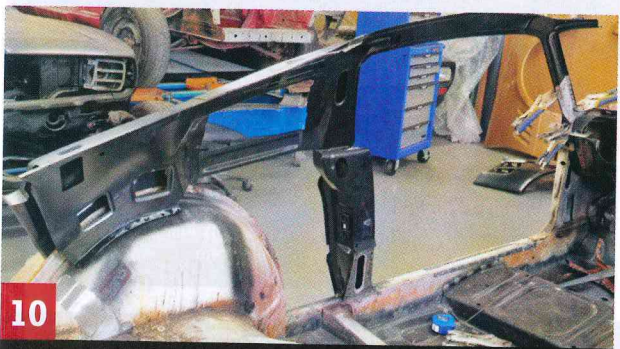
10

The first test fit of the new side section to the original body. The factory B-pillar support mates with the section of the Taiwanese B-pillar that was cut away in the previous shot. Drill screws and clamps holds everything in place at this stage.

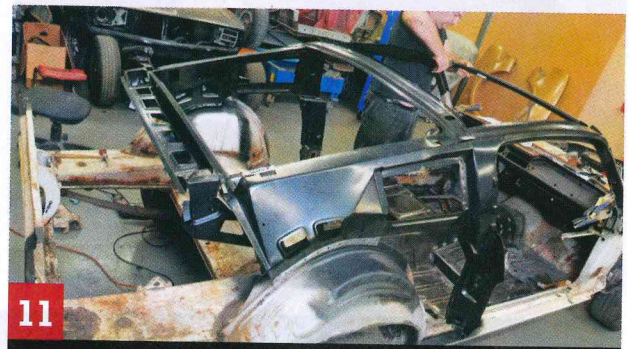
11

Leo sets roof section cross-braces in place. These are clamped with Visegrips and may have to be reset several times before the transverse dimensions of the new panels are correct. Careful measurement will be required to match the cross-braces to the new sides of the car. The boot divider is also set in place and used to determine the width.
