This is a Quarter Doorframe Assembly. To fit one to each side of a car, the body needs to be held in a jig otherwise it would distort due to the amount of metal required to be removed.

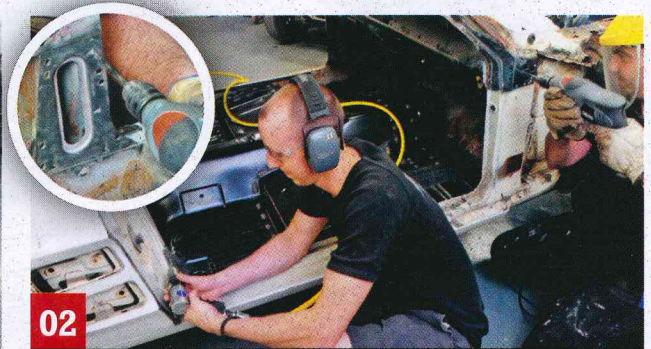
02

Shane (left) is drilling out spot welds in the B-pillar support. This very important area must be retained. The inset shows the opposite support from the inside. George is drilling out spot welds that attach the lower outer skin of the A-pillar to the body sandwiched in behind the upper door hinge.

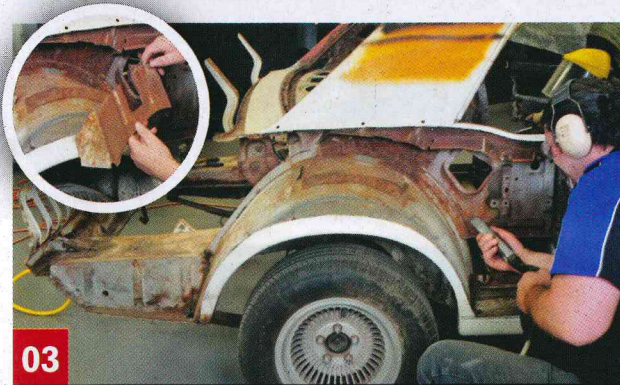
03

The section shown in the inset was cut away with a power hacksaw and removed so that the inside section at the pinch joint between both halves of the wheel well could be reached and cut as shown.

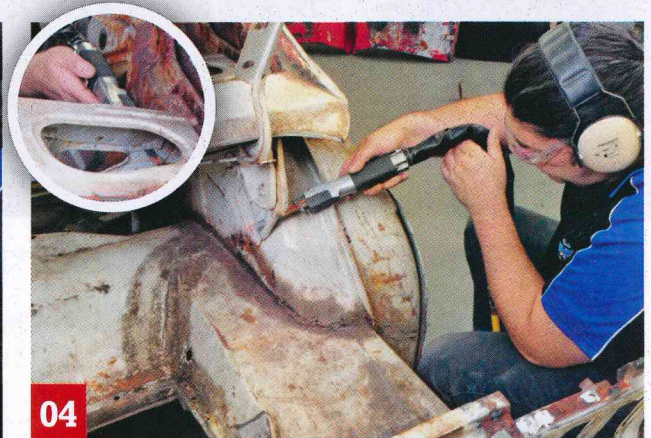
04

The boot hinge is next, along with the boot divider under the rear parcel shelf, as shown in the inset.

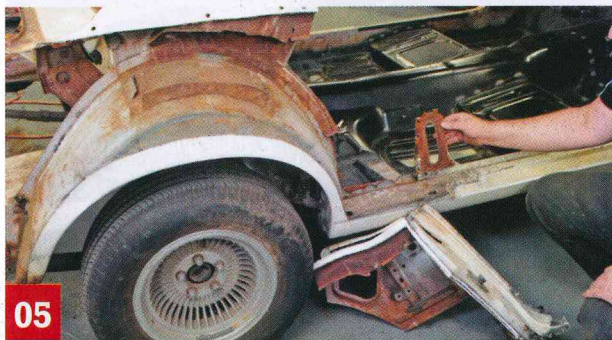
05

The B-pillar support has been preserved. It's sandwiched between inner and outer sill panels and serves as a guide when fitting the new panels. This is drilled because they will weld through the holes to secure the new panel. Look at the rust. And this is a clean car!

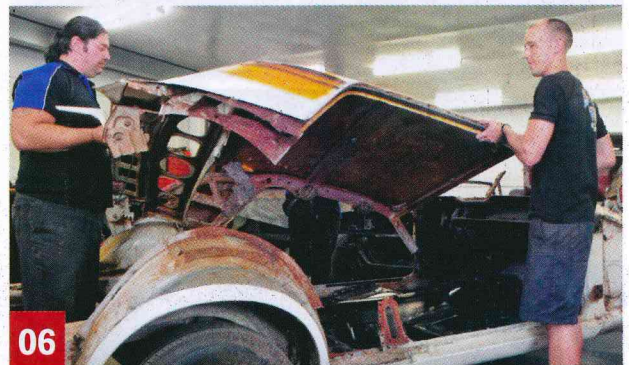
06

Inexperienced operators may go to lift the roof off a couple of times only to find that there's still something preventing it. Eventually, though, all the connection points will be found and it will lift free as shown. It's quite a milestone.
